**Final Report from the Cayman Islands Tourism Association as to how the Kittiwake project met the goals of the *National Guidance: Best Management Practices for Preparing Vessels Intended to Create Artificial Reefs (BMP Guidance)*, May, 2006 (71 FR 27716). "BMP"**

**Date: July 6, 2010**

**Overview:**

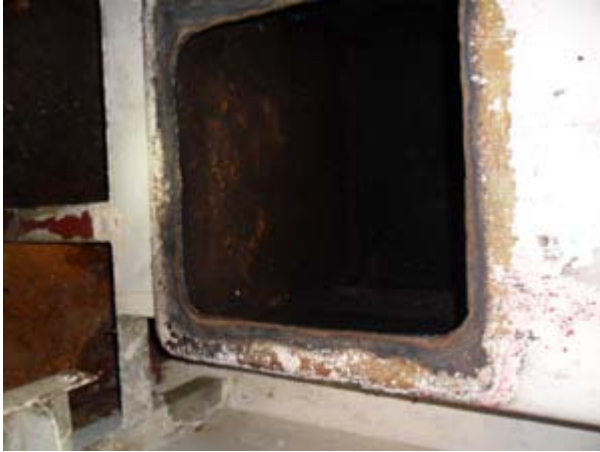
All six day tanks for fuel had sludge and small amounts of remaining fluids or sludge.

While manpower intensive, this cleaning method limited the spread of contamination and did not generate much fluid waste to dispose of, given the type of steam cleaner used with minimal steaming hot water discharged. All day tanks for fuel were inspected, then holes at the sides near the bottom of the tanks were cut in each tank that measured approximately 3 feet by 3 feet. A photo of a day tank cut open as an example is shown at left. While empty, the day tanks contained fuel residue and sludge

like material. The sludge was scraped out into buckets, then rag wiped by hand, with the opening large enough for a person to enter. Following hand ragging, all day tanks were pressure washed with a mild degreaser solution, then ragged and dried again by hand. Minimal water volume was used; instead using very hot steam. A ratio of water to degreaser of 1:25 was used to minimize degreasing/cleaners. The surface of all fuel tanks are dry and fuel free. No tanks were left sealed; all tanks are open to easy visual inspection, which also assists in the sinking process by creating minimal air pockets.

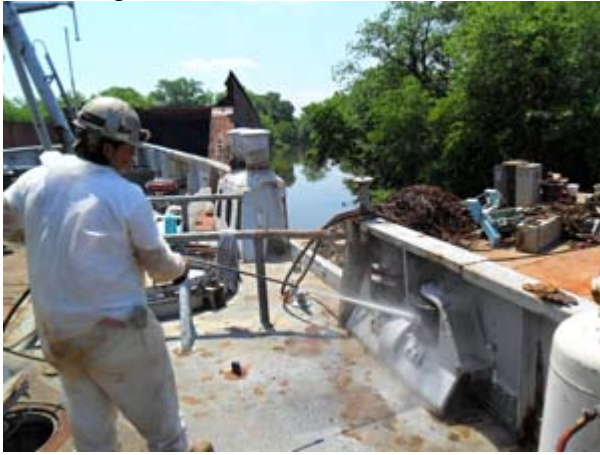
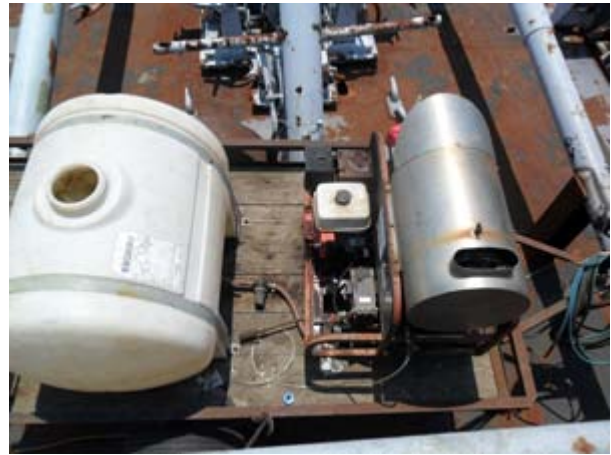
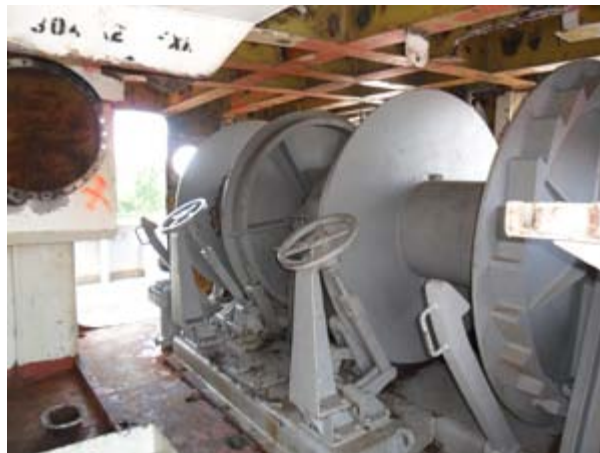
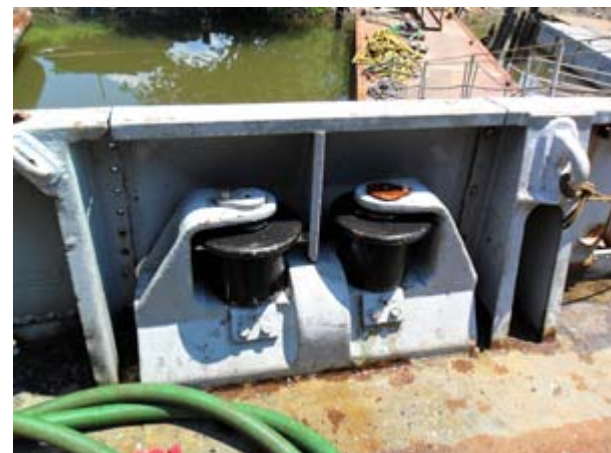
Between mechanical cleaning and hot steam cleaning, all tanks were able to be cleaned to satisfactory standards. Photos of pressure washer and cleaned winches are shown following.

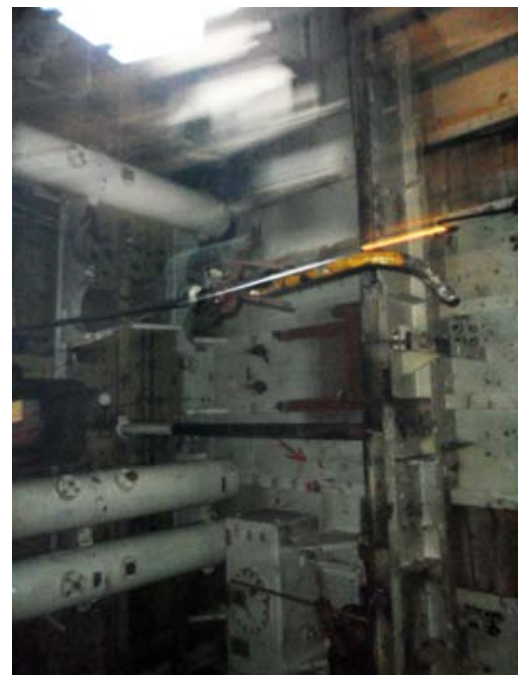
Fuel lines and all pipe fittings were all opened, and all flanges were cut on either side to insure both visual and hand inspections were possible. Ninety percent of all fuel lines in the shaft alley, engine room and propulsion room were removed, with the remaining lines cut open and exposed for visual inspection. A photo of a remaining cut fuel line (yellow) is shown at right.

The majority of fuel lines were found to be clean and empty; several fuel lines required cleaning and 2 fuel lines had fuel still inside, that emptied when cut into the propulsion room and shaft alley respectively. The quantity of fuel was approximately 10 gallons, which was scooped into buckets, then surfaces ragged and cleaned, and then steam cleaned again. These fuel lines were flushed with steam and cleaned after draining. Other fuel lines were inspected and found to be dry and fuel free. Fuel lines were cut throughout the ship, including in the shaft alley, engine room, propulsion room, generator room and towards the forward peak. All fuel lines were yellow in color. All pipe openings are dry and fuel-free to the touch. There are no fuel lines that are not cut and exposed to visual inspection.

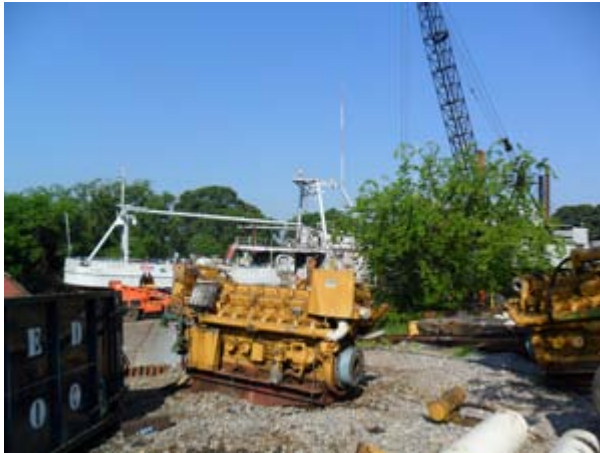
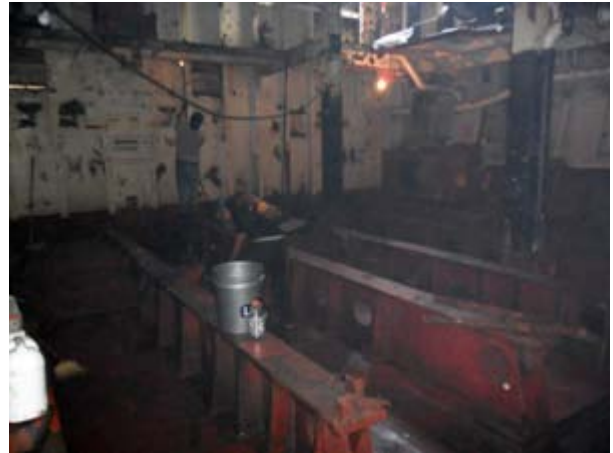
All combustion engines have been removed from the Kittiwake, including the 4 main Caterpillar engines. All engines removed will remain in the US for recycling or parts. Photo of the empty engine room is shown at right along with 1a photo of 2 of the engines on shore.

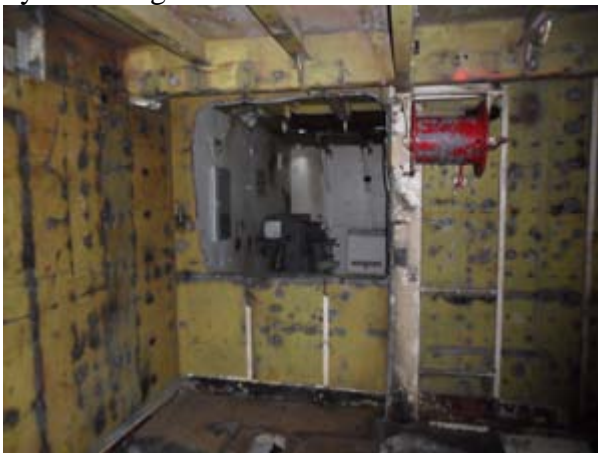
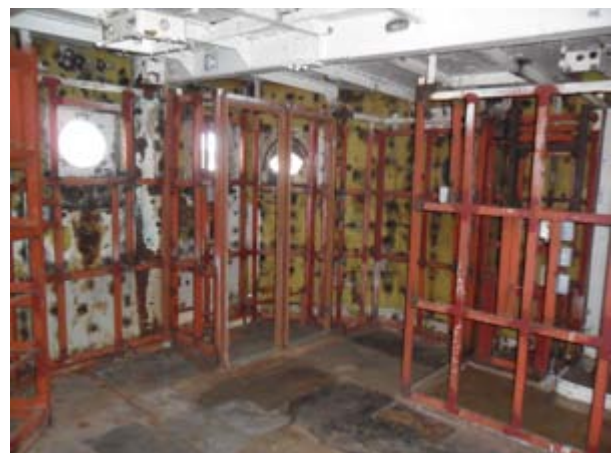
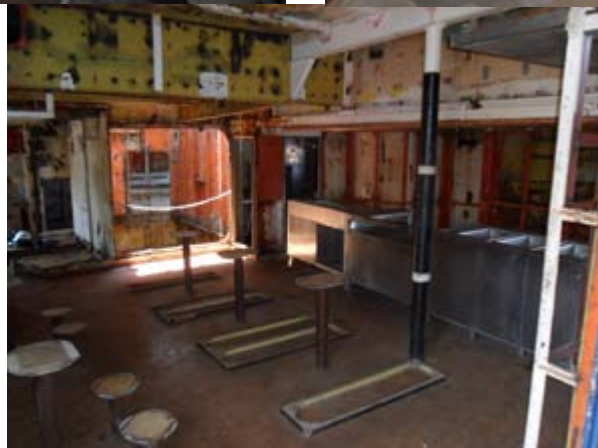
The first pass of Asbestos remediation removed or eliminated 100% of all lagging and about 90% of all interior insulation materials. Following this, the final 10% off all insulation materials were hand scraped in the second pass. In both instances, vacuum and brooming were used to clear up any remaining material from the decks. Samples of rooms (engine room, XO quarters, galley) show the bare metal hulls that were achieved by removing all insulation.

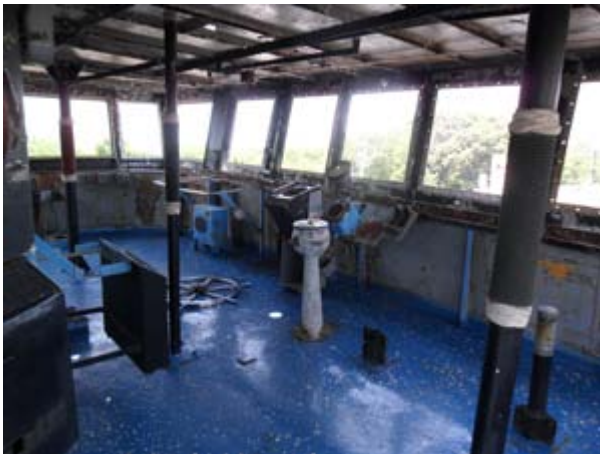
Some flooring remains that is sealed (non-friable) part-asbestos in 2 areas of the crew quarters, bridge and the recompression chamber. In the recompression chamber, the flooring was intact except for one corner and where minor peeling was observed which was screwed down and covered by a steel plate to prevent further peeling. Any other loose/peeling areas of flooring were scraped and disposed of, such as crew quarters 1 and 2. As a part of the perpetual maintenance plan in Cayman, should any parts of the ship become loose or floatable, they will be removed by the maintenance crew during monthly inspections, and disposed of in the land fill. Photos following are the bridge showing intact flooring. As this eventually deteriorates, the monthly vessel maintenance plan calls for a dive crew to visit the Kittiwake each month, perform routine maintenance such as removal of any loose debris, report any more significant maintenance needs for follow up and report to the Cayman Islands Department of the Environment all findings. The Maintenance plan is a part of the binding Coastal Work License. The Maintenance Plan is Appendix 13 of the Nov 2008 Application to MARAD.

Intact Bridge Flooring

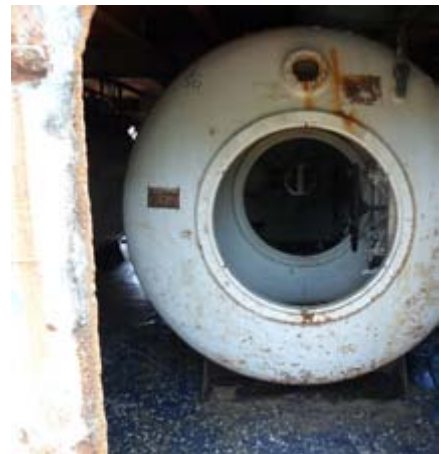
Intact Chamber Flooring

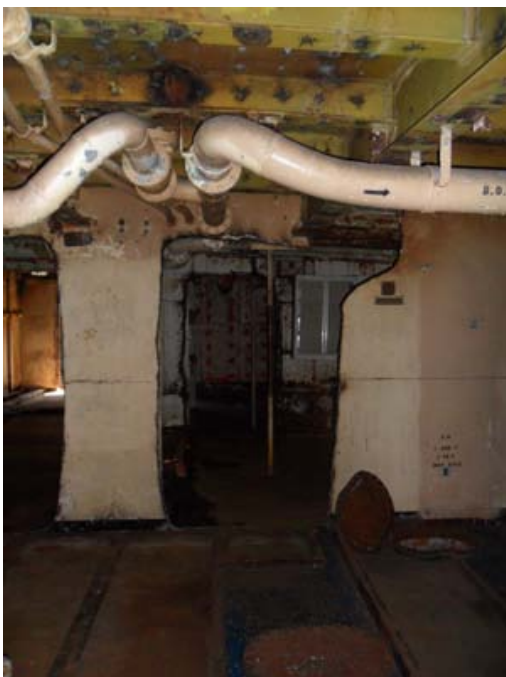
< Crew quarters scraped of all loose flooring

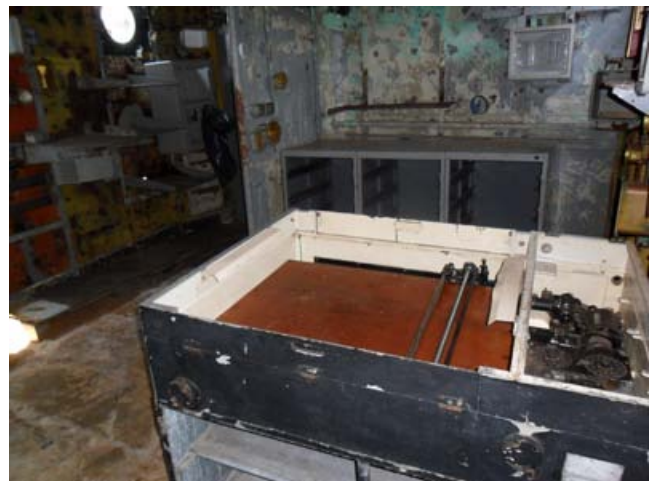
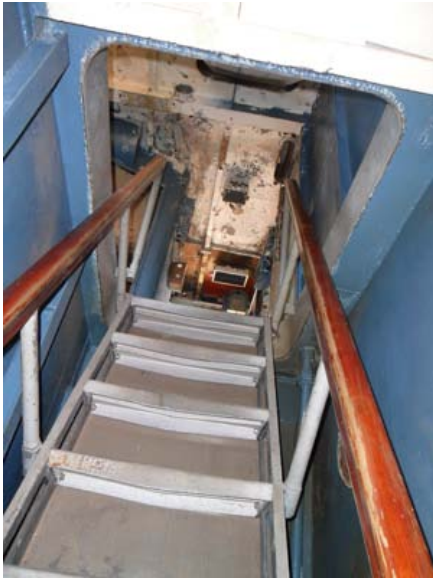
All carpet, wood and other porous materials (except not all paint) has also been removed as a potential contamination sources of PCB's, in

addition to these items being a fast deteriorating item. One exception would be 2 wooden railing in the upper 2 ship levels from the bridge to the XO's quarters that are in good shape and intact. The railings will be removed in Cayman prior to sinking, but are needed for top side viewing prior to sinking. The second exception is a wooden board (about 3' x 3') in the plotting table (top deck), that will be sunk with the ship, and eventually removed due to deterioration by the monthly maintenance crew. Photos are shown above.

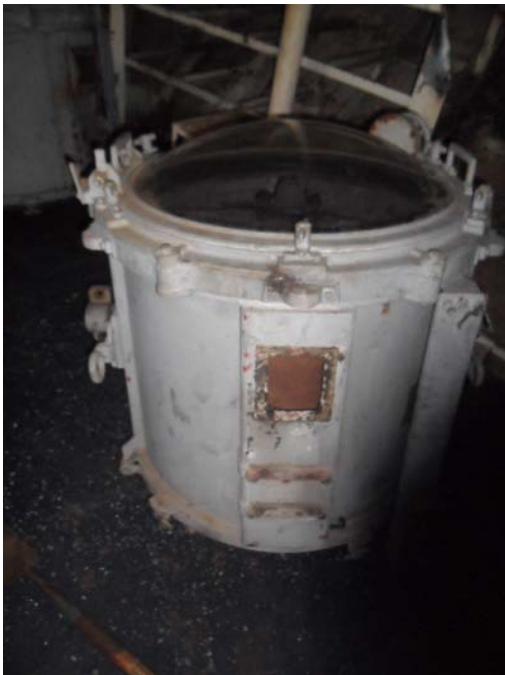
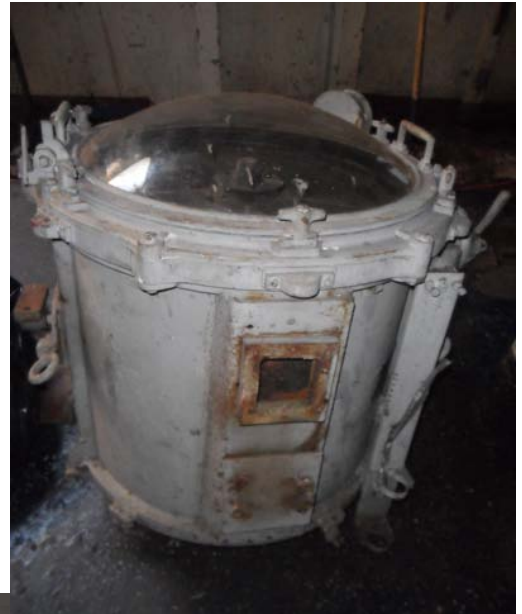
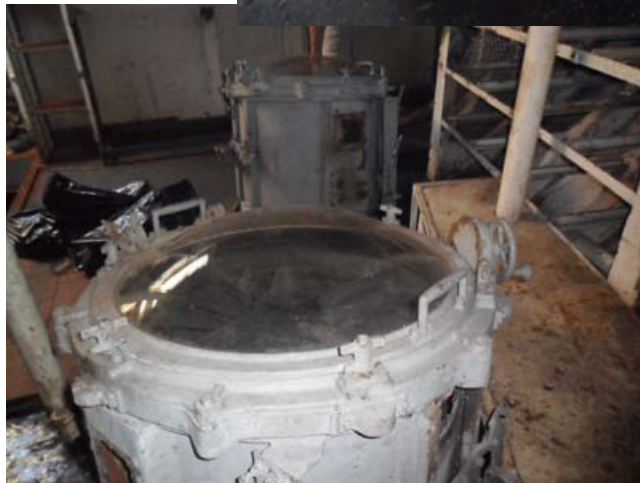
The two spotlights that remain on board the Kittiwake for display in Cayman have been gutted of all electrical cabling, motor, transformers and capacitors. Photos of the spotlights are shown following taken on June 24, 2010.
